DEPARTMENT OF CONSERVATION AND NATURAL RESOURCES
DIVISION OF WATER RESOURCES

Re: Yerington Mill No. 2, (NV00200)

On December 11, 2015, Edmund Quaglieri P.E., and Colette Easter, P.E., inspected Yerington Mill No. 2 Dam. The purpose of the inspection was to determine the condition of the structure with respect to dam safety. The Yerington Mill # 2 Dam is classified as a **significant** hazard dam due to downstream development or activity.

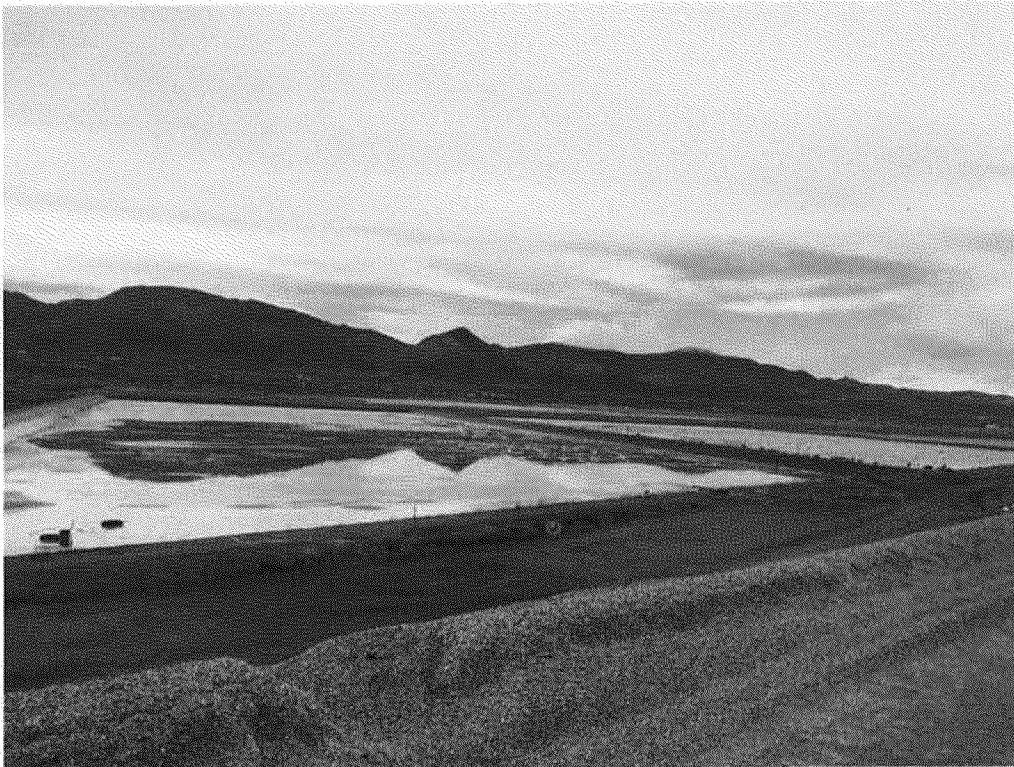
Yerington No. 2 Dam; General condition of the dam. Lined ponds are detaining stormwater runoff.

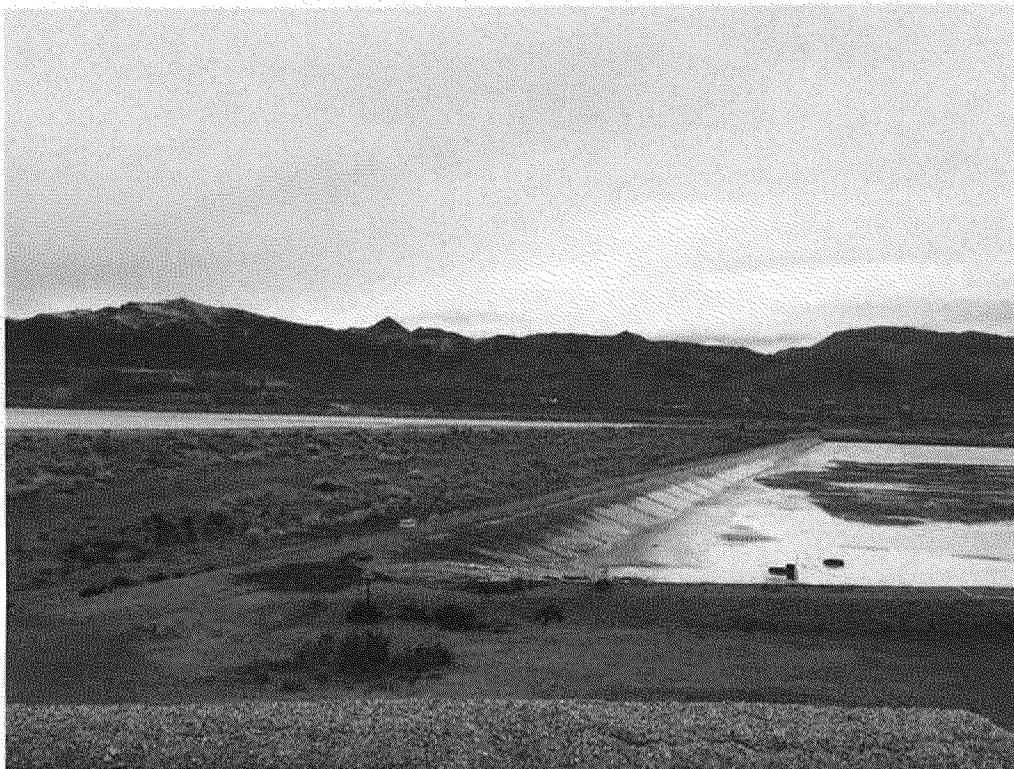
Yerington No. 2 Dam; General condition of the crest of the dam and liner looking West.

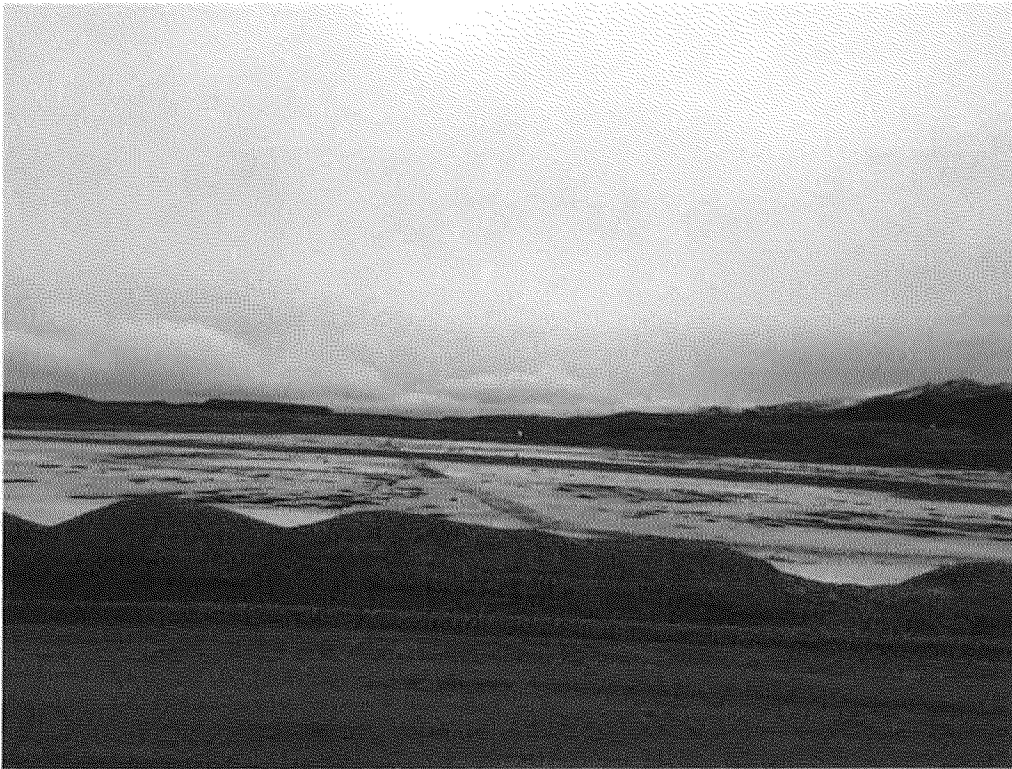
Yerington No. 2 Dam; General condition of the impoundment looking East.

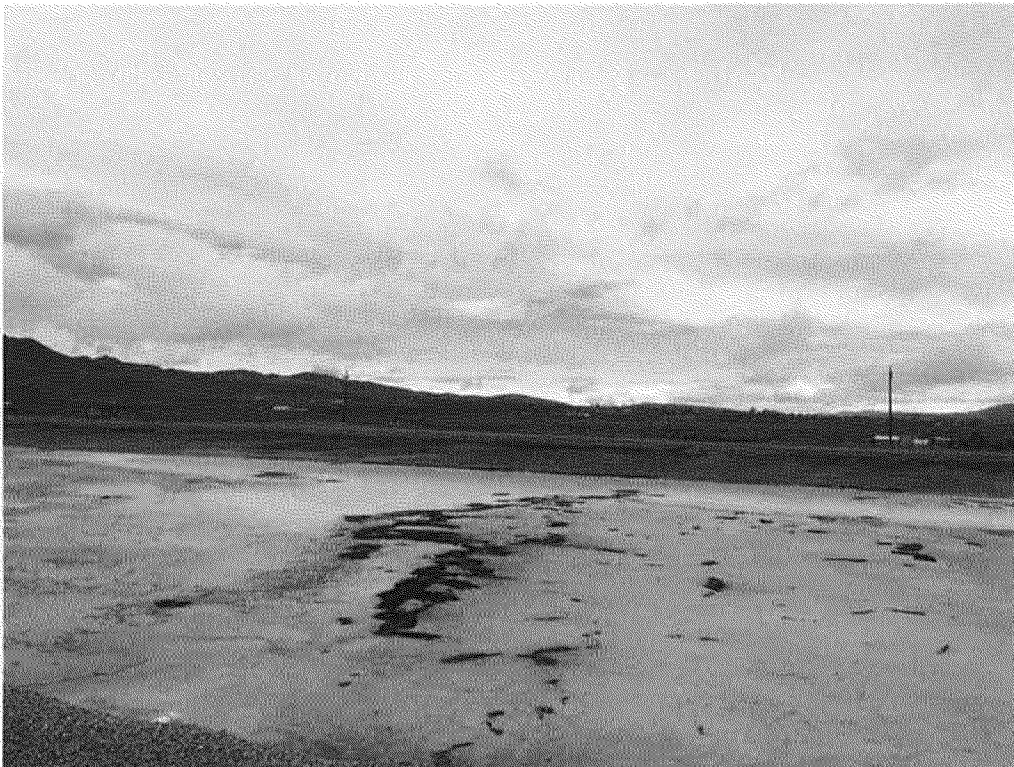
Yerington No. 2 Dam; Stormwater along the North upstream embankment.

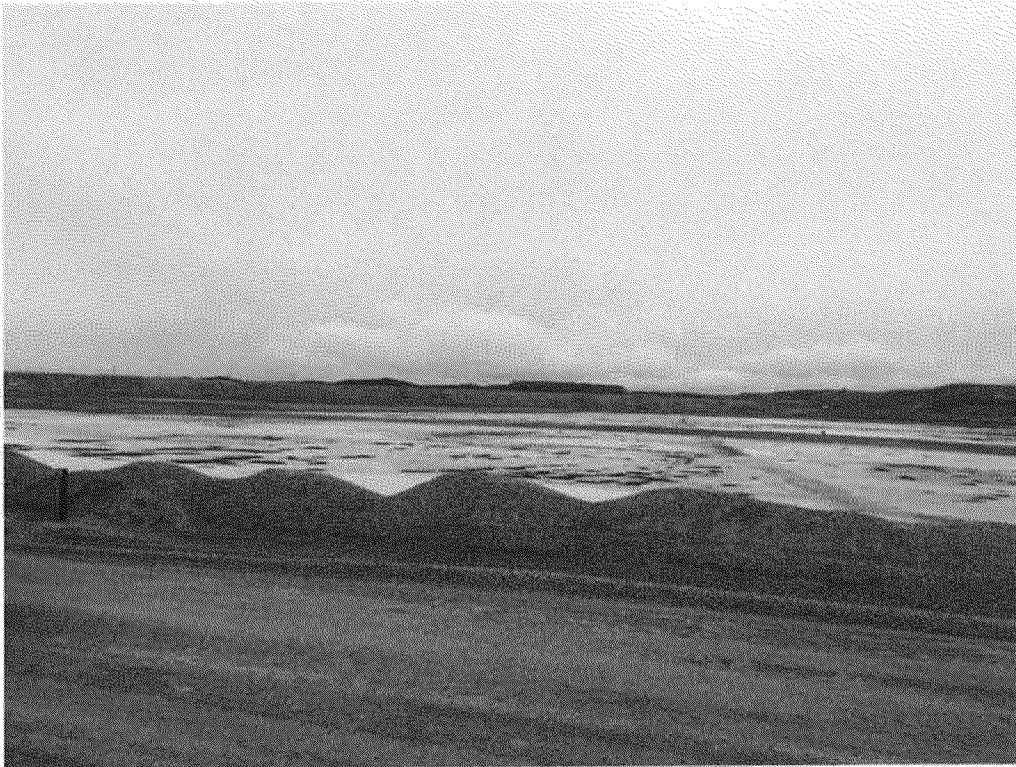
Yerington No. 2 Dam; General condition of impoundment looking south.

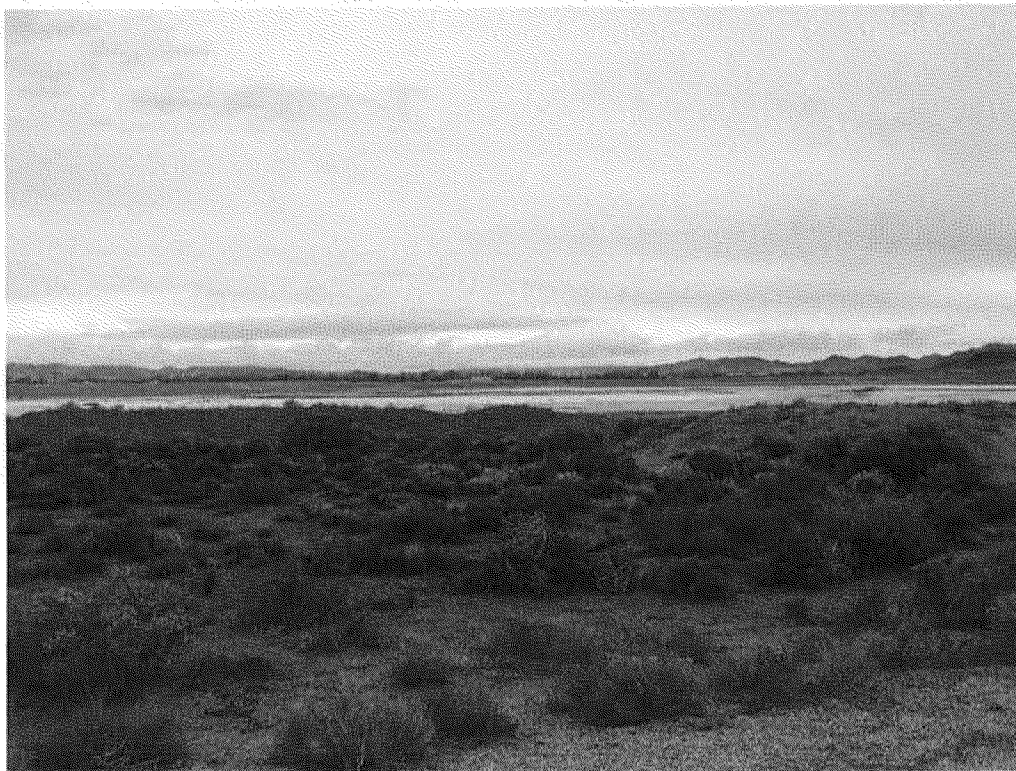
Yerington No. 2 Dam; General condition of impoundment looking east.

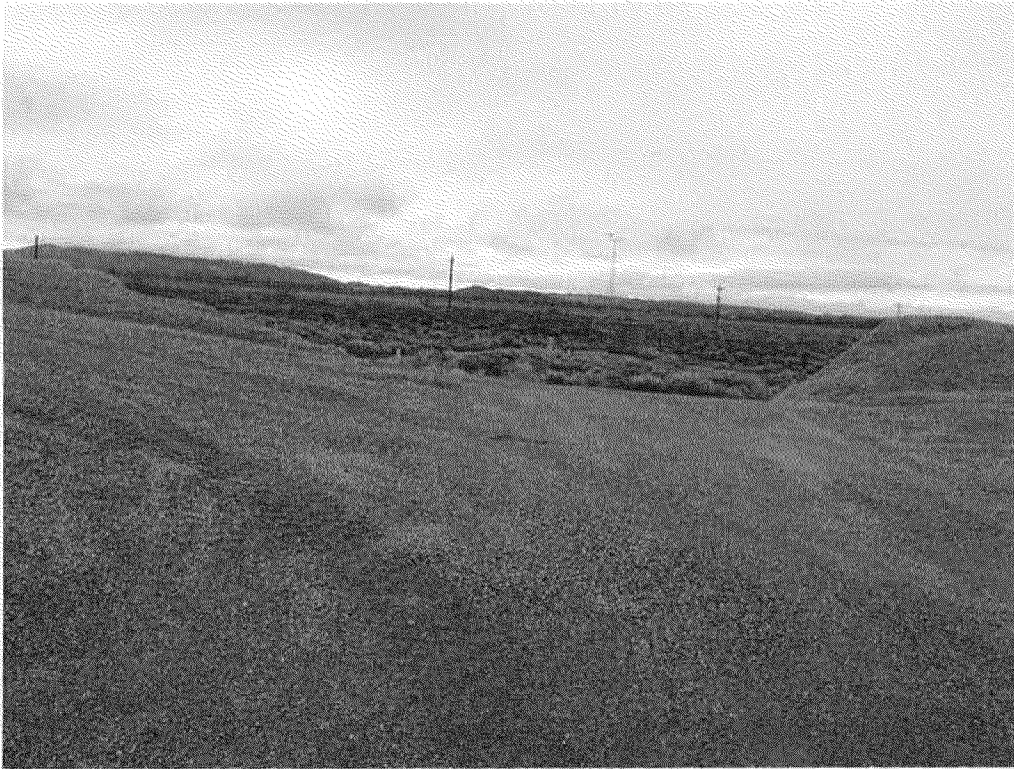
Yerington No. 2 Dam, There are points along the crest of the dam that are lower in elevation due to vehicle traffic. The crest should be maintained at a constant elevation or according to design.

- 1) Ruts and gullies along the crest, downstream and upstream faces should be filled in and a camber established on the crest to encourage even runoff.
- 2) Areas along the crest of the dam that are lower in elevation due to vehicle traffic should be maintained at a constant elevation (or at design elevations).

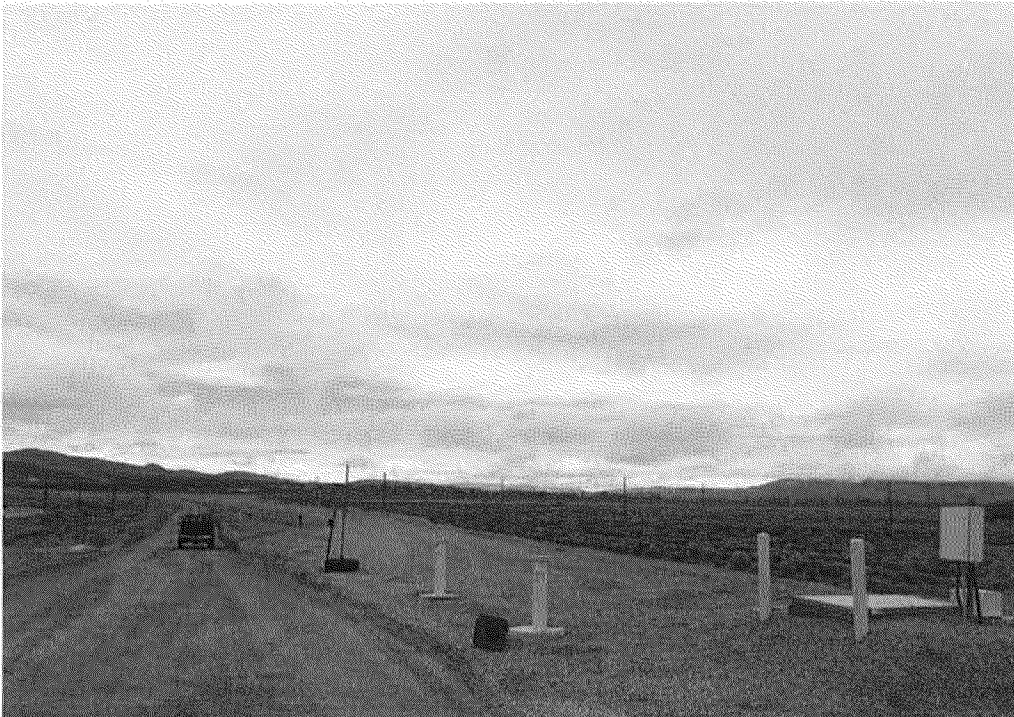
Yerington No. 2 Dam; General condition crest condition along the north embankment looking west.
